THE BEAR INN PAGHAM

CASE STUDY

SUITABLE GREASE MANAGEMENT SOLUTION

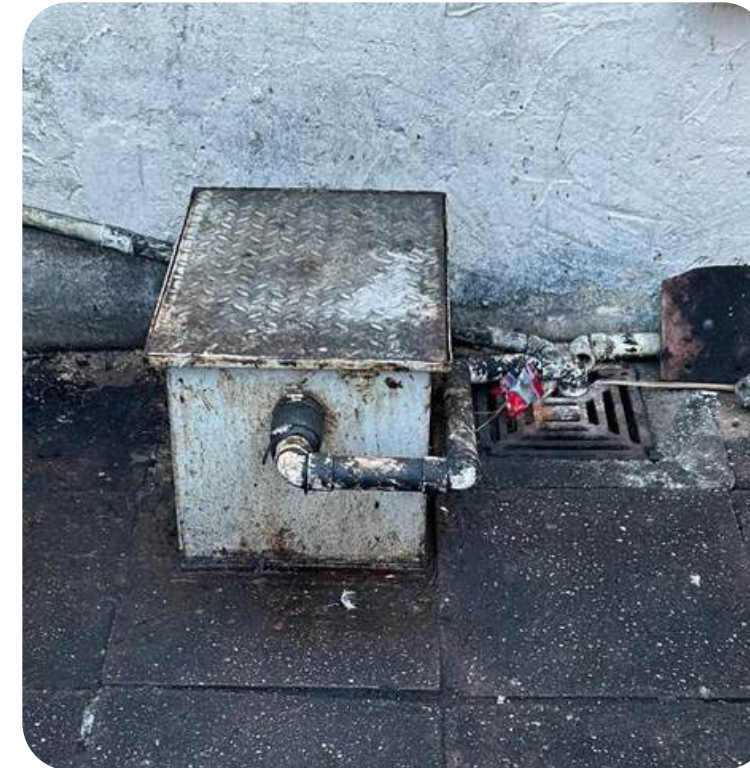
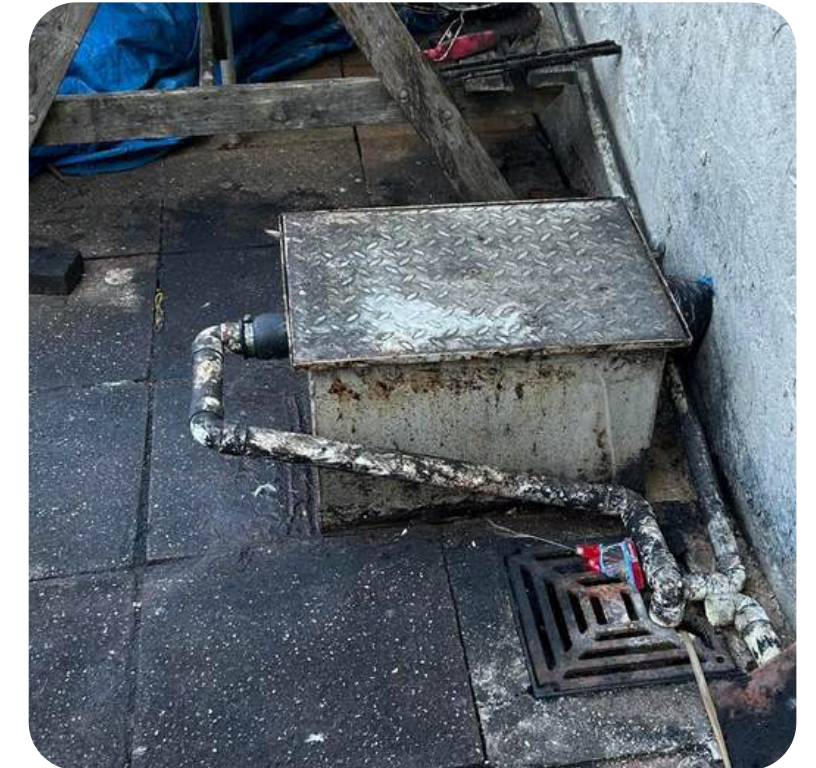
Non Compliant Solution

- An old undersized passive grease trap that was malfunctioning
- It was leaking over the rear yard
- Creating Rodent issues
- Slip Hazards
- Failing to prevent FOG from entering the sewer

Installation of a Passive Grease Trap

Based on the findings, a cost-effective passive grease trap was selected, providing equivalent compliance to a grease removal unit at roughly one-third of the cost.

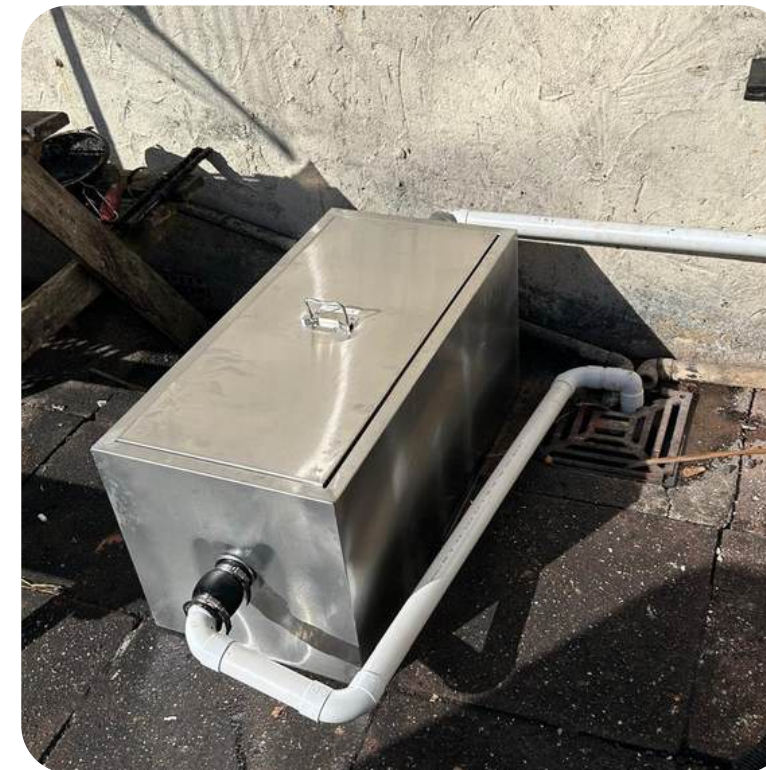
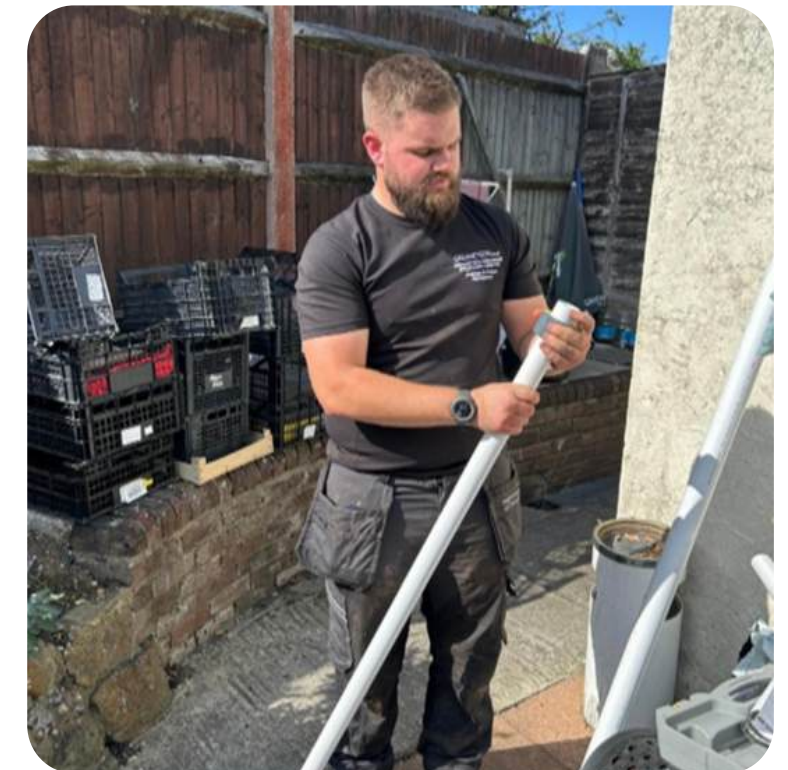
New Passive Grease Trap

- **Cost-Effectiveness:** The affordable solution significantly reduced the financial burden on The Bear at Pagham while maintaining full compliance with LWA standards and regulations.
- **Prevention of Blockages:** The installation of the grease trap and a proactive maintenance plan will help mitigate the risk of future FOG-related blockages in the village.
- **Stakeholder Satisfaction:** All stakeholders, including the LWA, ECAS, and external auditors, were consulted with in a collaborative effort and recognised and agreed on a realistic, effective solution which is compliant and affordable.

A follow-up visit is **scheduled three months** post-installation to conduct the first quarterly **maintenance and cleaning**, ensuring the system continues to **operate effectively**. The successful implementation of this solution serves as a model for other single-owner operators in similar situations facing **regulatory pressures** and **financial constraints**.
